**NASA TECHNICAL
MEMORANDUM**

NASA TM X-68282

TANK FRAGMENTATION TEST

by C. J. Daye, D. Cooksey, R. J. Walters, and A. E. Auble
Lewis Research Center
Cleveland, Ohio 44135
August 1973

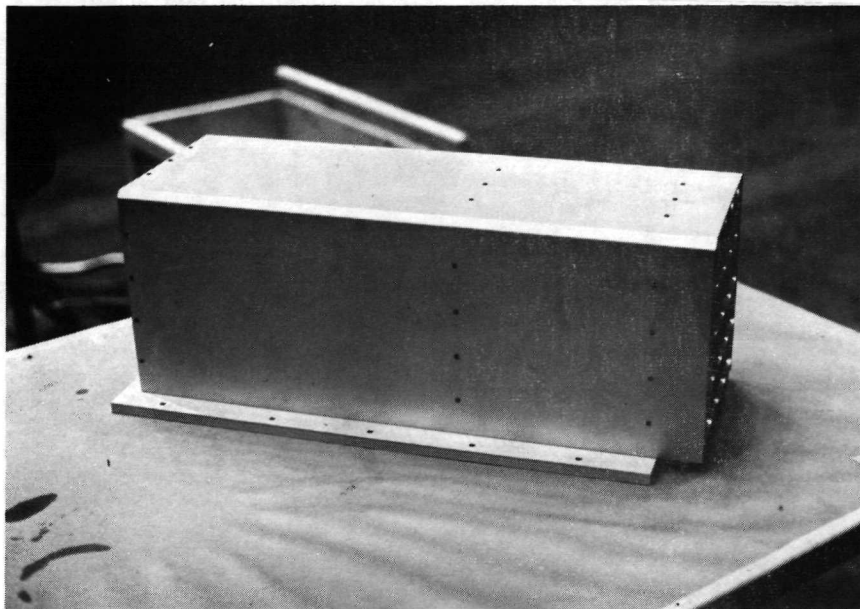
Figure 1. - Ejector assembly.

The test article consists of 20 tubes containing 16 disks, eight aluminum and eight stainless steel, and four teflon spheres. All disks were one inch in diameter and 0.1 inch thick; the spheres were one inch in diameter. The tubes were arranged in a rectangular array approximately one square foot in cross section. The overall length of the assembly was about 30 inches, and its weight was 46 pounds. All 20 objects are ejected simultaneously from the tube array by pistons actuated by gas pressure built up when a small detonator is fired. Nominal ejection velocity was predetermined to be about 60 ft/sec. In addition, the test article was designed to eject the disks at a predetermined tumble rate, and with a single specific orientation of all tumble axes. The tube array is arranged to produce a slightly diverging pattern of ejected objects; it is called the Ejector Assembly, and a photograph of it is shown in figure 1.

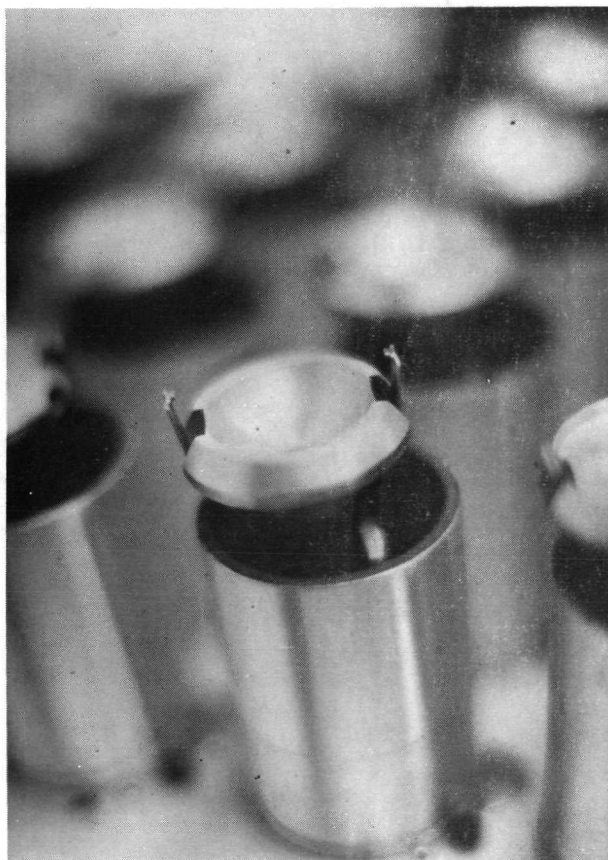
Figure 2. - Exit plane of ejector assembly after test showing how discs and spheres were held in place.

Figure 2 shows how the ejected objects were held in the tubes. Near the end of travel, the spring-clamps moved outward, freeing the disks and spheres. For details of this test article concept and design, consult cognizant personnel at the Space Data Corporation.

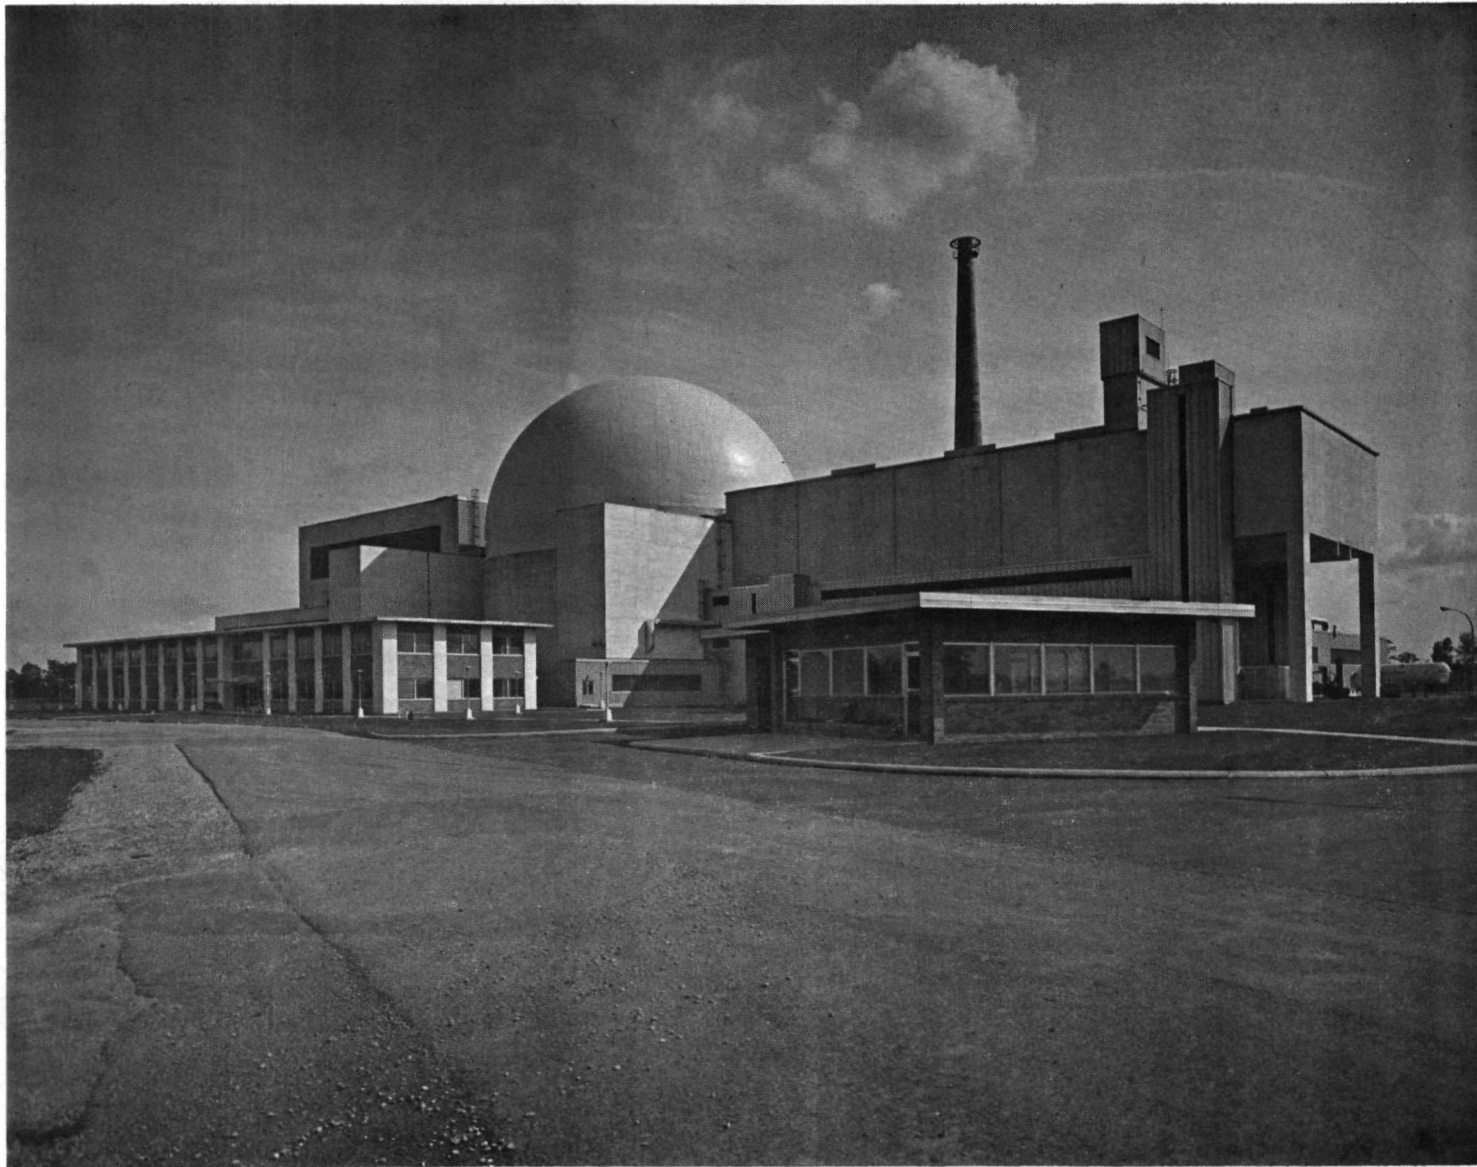
Figure 3. - Lewis Research Center's Space Power Facility.

The Space Power Facility has been briefly described elsewhere; essentially, it is a large controlled environment chamber, 100 ft in diameter and 122 ft high, being a domed cylinder configuration with a flat floor at ground level. Altitudes from ambient to orbital (10^{-7} torr range) can be obtained in this chamber. A wide range of test chamber temperatures is available also (temperature simulation was not required for this test). An external photograph of the facility is shown in figure 3.

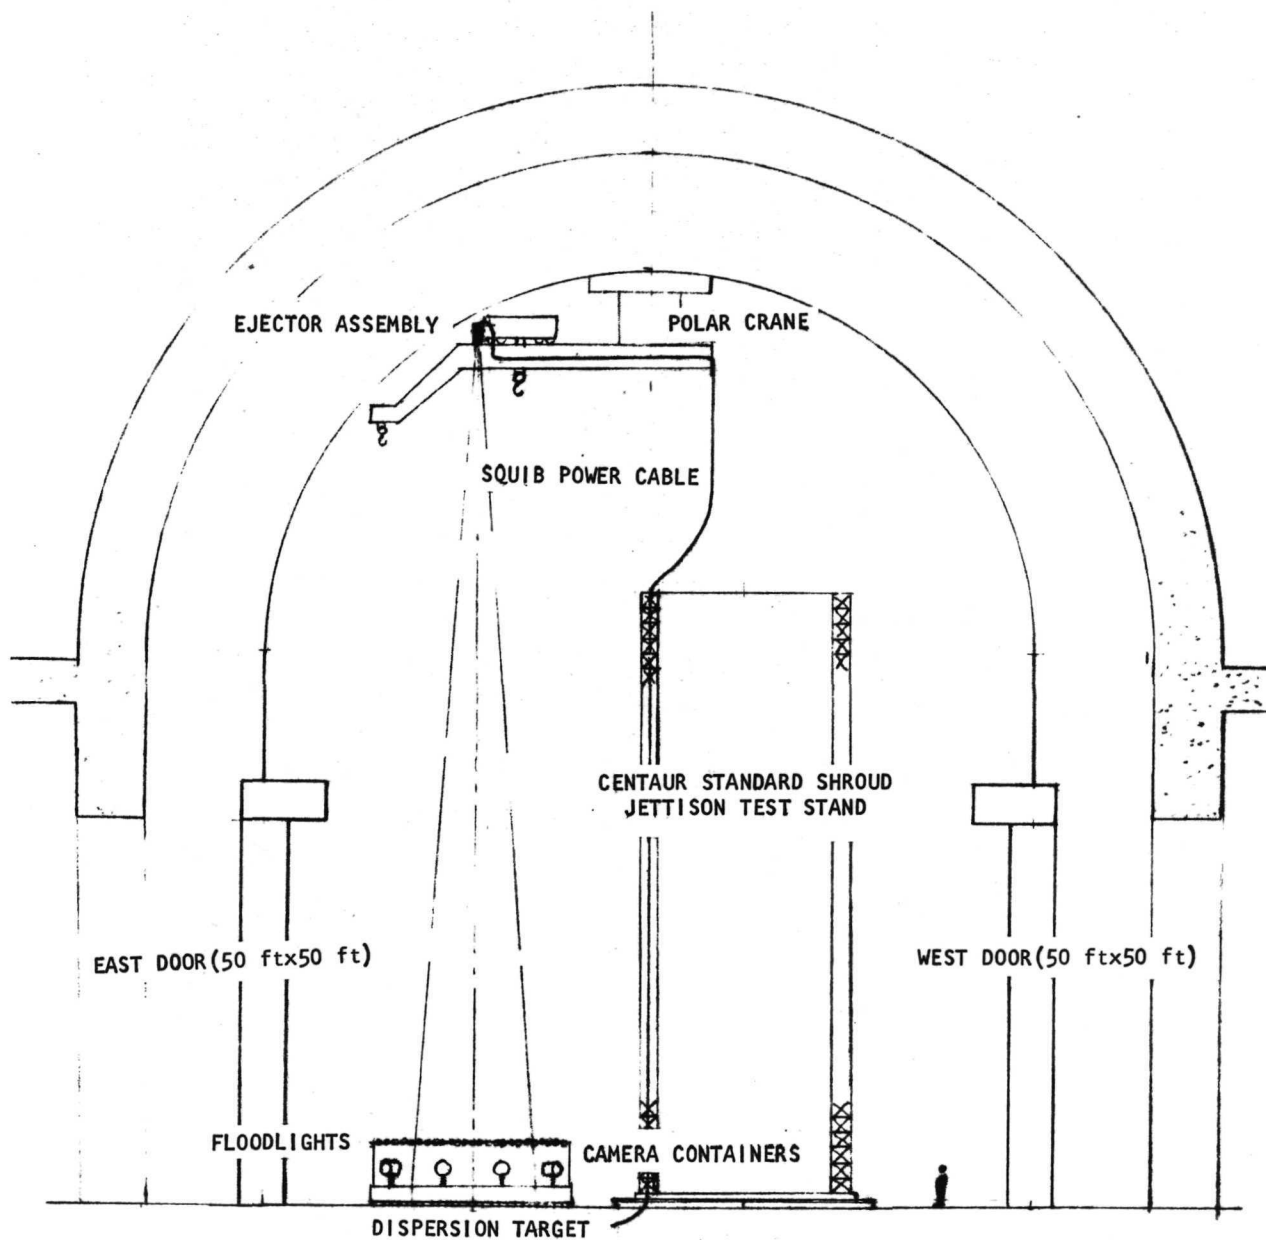
Figure 4. Tank Fragmentation Test
Configuration in Lewis Research Center's
Space Power Facility

The sketch of figure 4 shows the configuration used for the Tank Fragmentation Test. The view shown is looking south, across the east-west centerline of the chamber. The Ejector Assembly was mounted on the facility polar crane trolley, near the apex of the chamber dome. It was oriented vertically, such that the disks and spheres were ejected downward, impinging on a target on the chamber floor. The actual distance from the exit plane of the Ejector Assembly to the target surface was 110 ft. The Dispersion Pattern Target was squared-drafting paper mounted on a wooden frame 20 by 30 ft in area. The paper was supported by fine wires strung across

the target frame. The frame positions the target 2 feet above several layers of an energy-absorbing material (cellulose packing wadding) distributed in the floor of the target box, to prevent any bouncing which could have resulted in a target puncture from the wrong side. The dispersion pattern was obtained by measuring the places where the ejected spheres and disks pierced the target paper and landed in the energy-absorbing material below.

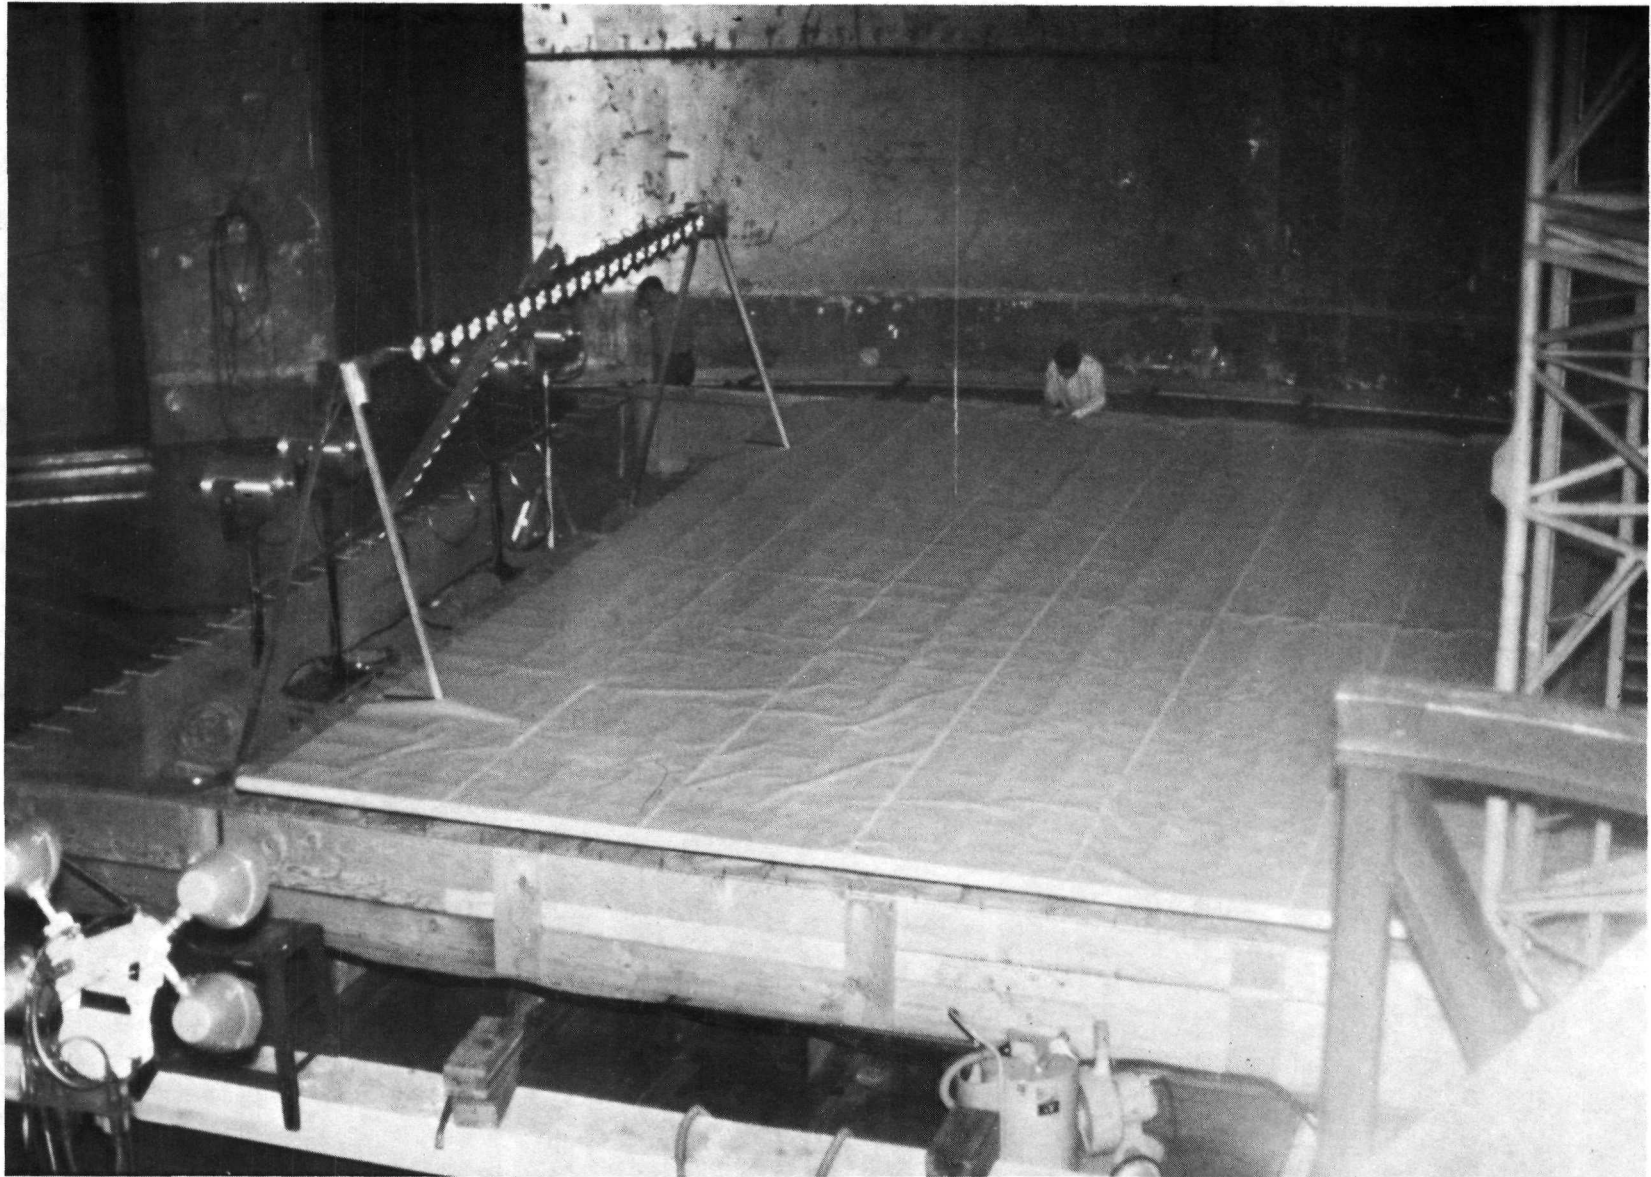
Figure 5. - Dispersion target, floodlights and cameras in place in the east half of the Space Power Facility.

Four high-speed motion picture cameras (nominally 1000 frames/sec) and associated floodlighting were mounted along the north edge of the target area, as shown in figure 5. Both the cameras and the Ejector Assembly Detonator required 28 vdc power; the floodlights required 110 vac. This power is readily available in the chamber. Camera run time was approximately 4 seconds. Table I lists the cameras, film linear speeds, lenses used, etc., in the test. All cameras were mounted inside sealed aluminum containers maintained at one atmosphere of air pressure. Each camera was provided with timing signals. These signals allowed the recording of the Ejector Assembly Detonator firing and the IRIG-A (Inter-Range Instrumentation Group-A) timing code along the edges of the film. This arrangement and equipment was used in the Skylab Payload Shroud Test Program (ref. 1) at the Space Power Facility. All camera optic axes were oriented horizontally across the expected target impingement area. Two cameras with wide angle lenses provided nearly complete coverage of the area while two cameras with high resolution lenses allowed measurements of good precision on individual disks and spheres to be made. The expected spin axes of the disks was in the north-south direction; i.e., the disks would be edge-on to the cameras. The optic axes of the cameras were 2.3 ft above the target surface.

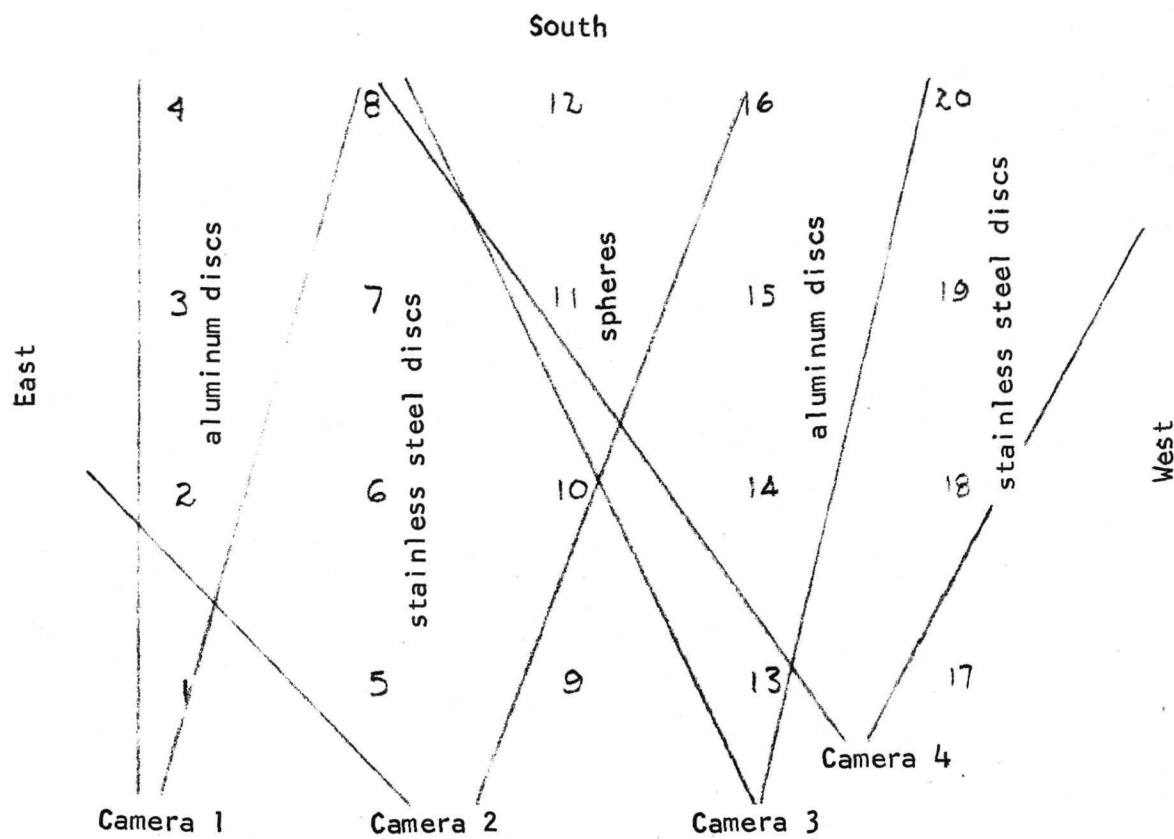
Figure 6. Identification Scheme for Discs
and Spheres (Looking Down)
Also shows field of view of cameras

Figure 6 presents the identification and orientation scheme used for the ejected objects in this test. Also indicated is the view field of each camera. Note that objects #9 (sphere) and #17 were not photographed by any of the cameras; this had no effect on the validity or usefulness of the test results.

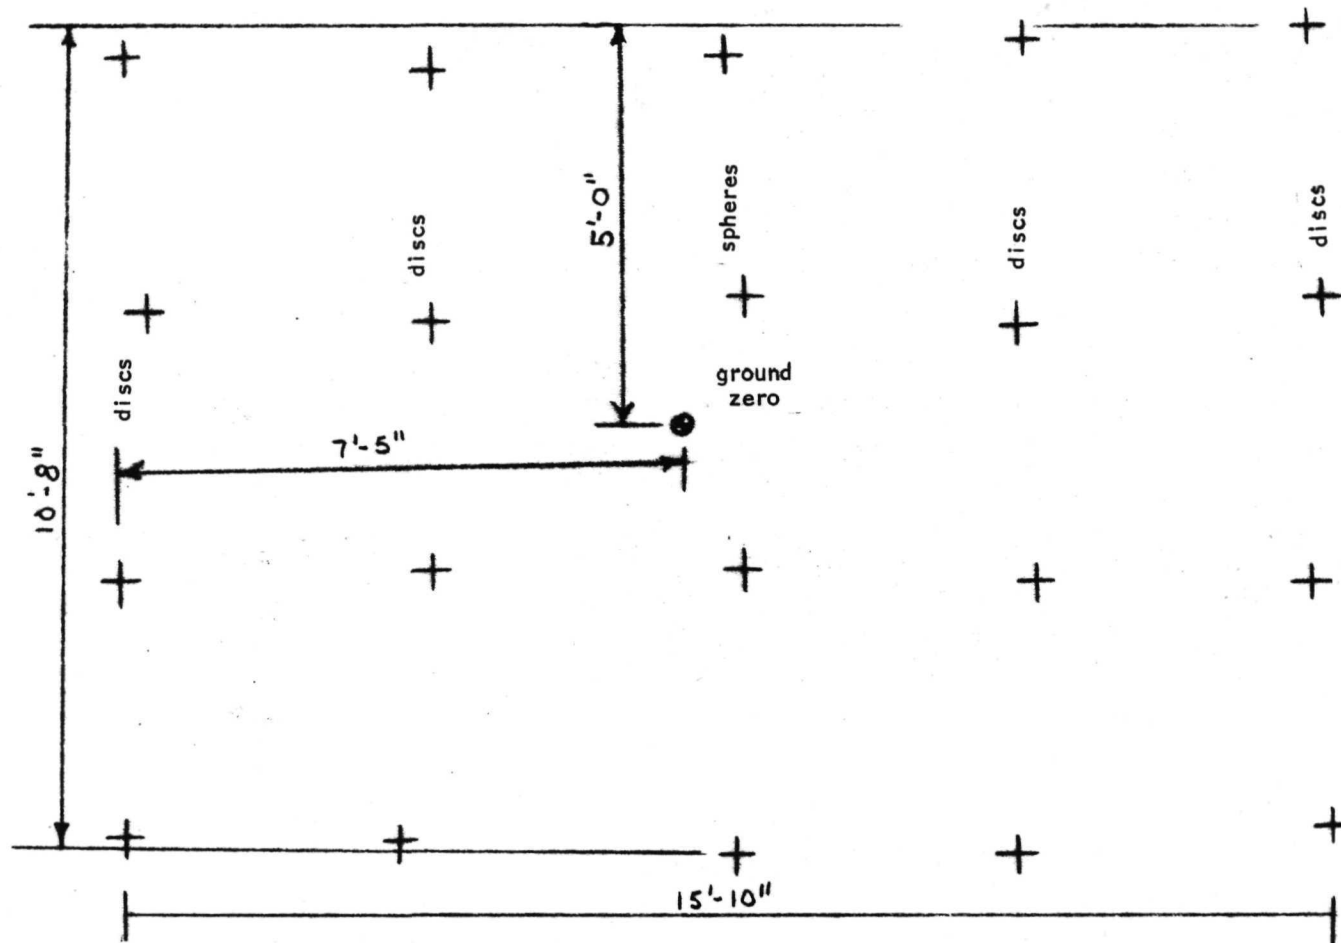
Figure 7. Tank Fragmentation Test
Dispersion Pattern

The dispersion pattern formed by impingement and (except in one case) penetration of the disks and spheres on the target is shown in figure 7. It can be seen that the measurements resulted in a reasonably regular array being indicated. The maximum outside dimensions of the pattern are shown and are 15'-10" east to west and 10'-8" north to south. The location of the projection of the axis of the overhead Ejector Assembly through the target is also indicated. This "ground zero" is seen to be 4" north and 5" east of the center of the enveloping rectangle, indicating a possible tilting of the Ejector Assembly in both the north-south and east-west directions of between 0.15° and 0.20° (9 to 12 min of arc). This was not considered significant.
